## Dyno-Scan for Windows Troubleshooting

### Vehicle Connection Issues

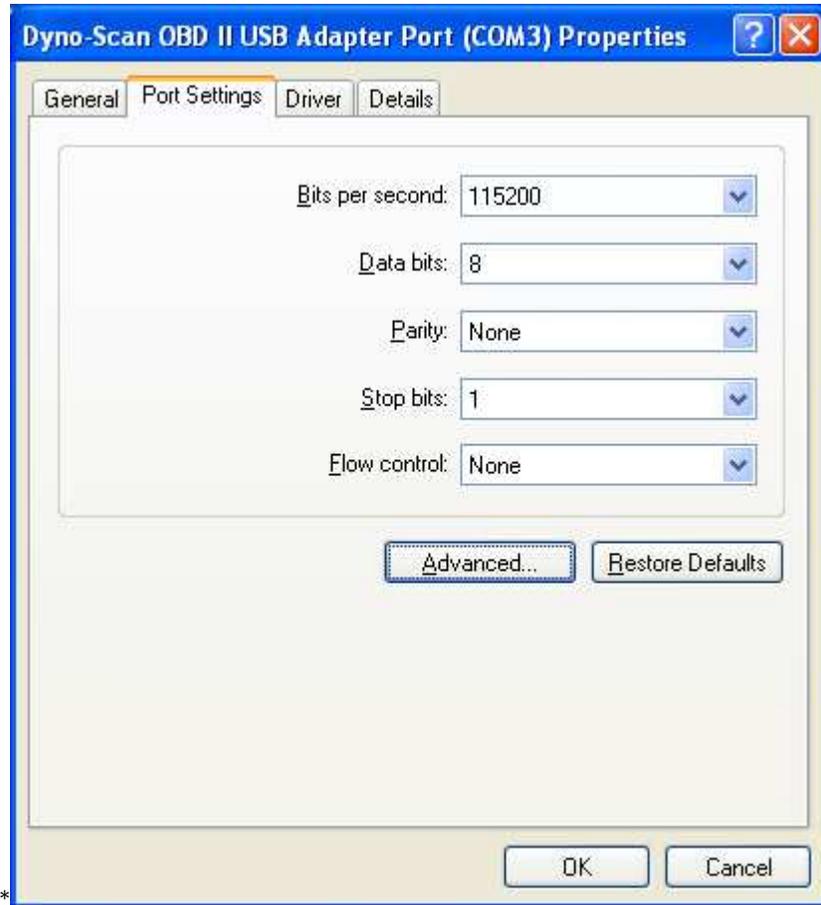
5) On the Port Settings tab press the Advanced... button.

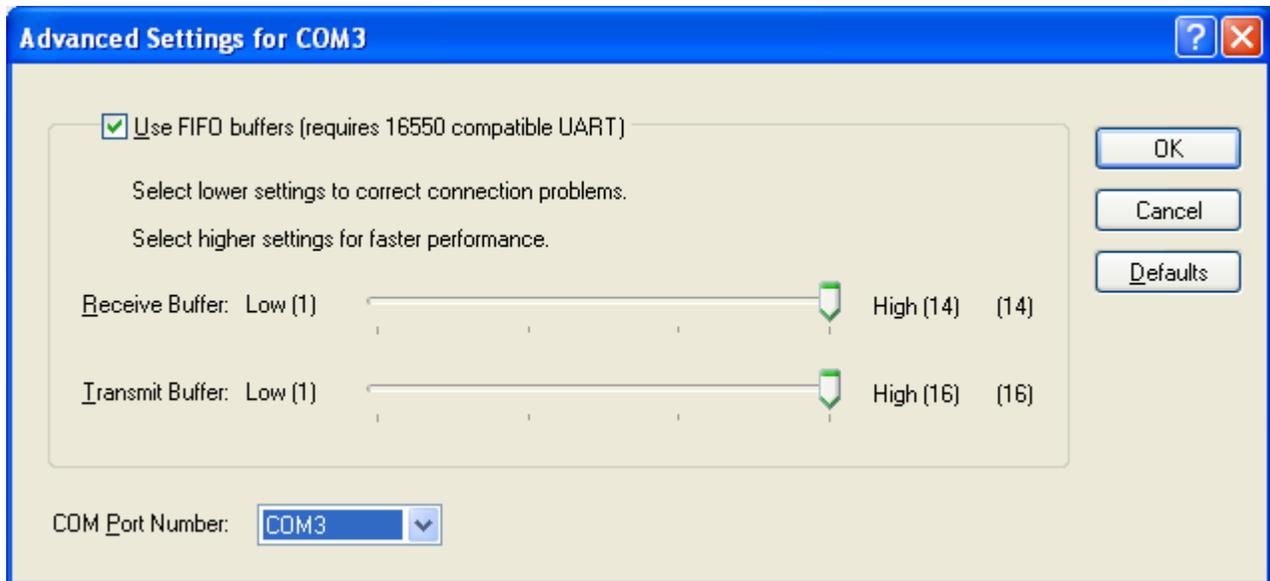
6) On the COM Port Number dropdown select another COM port. Try to select at COM5 or **higher** (e.g. COM5, COM6, COM7, etc). Press OK.

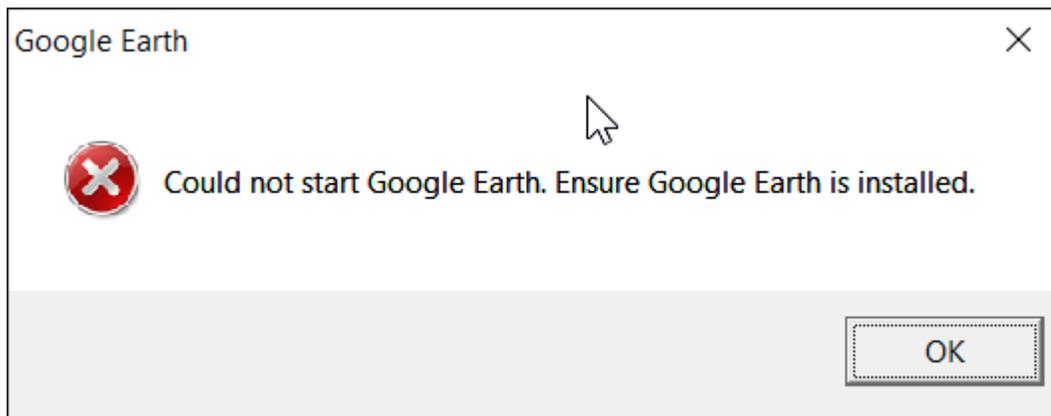
When opening a Live Data file and the Dyno-Scan for Windows Tools > Options > Google Earth tab > Enable Google Earth checkbox is selected you could receive the "Could not start Google Earth. Ensure Google Earth is installed." error message.
